Cost-effective Pipeline Strain Management

John Fang, Pipeline Manager

5th March 2026

Pipeline Integrity Management – Geohazard Management

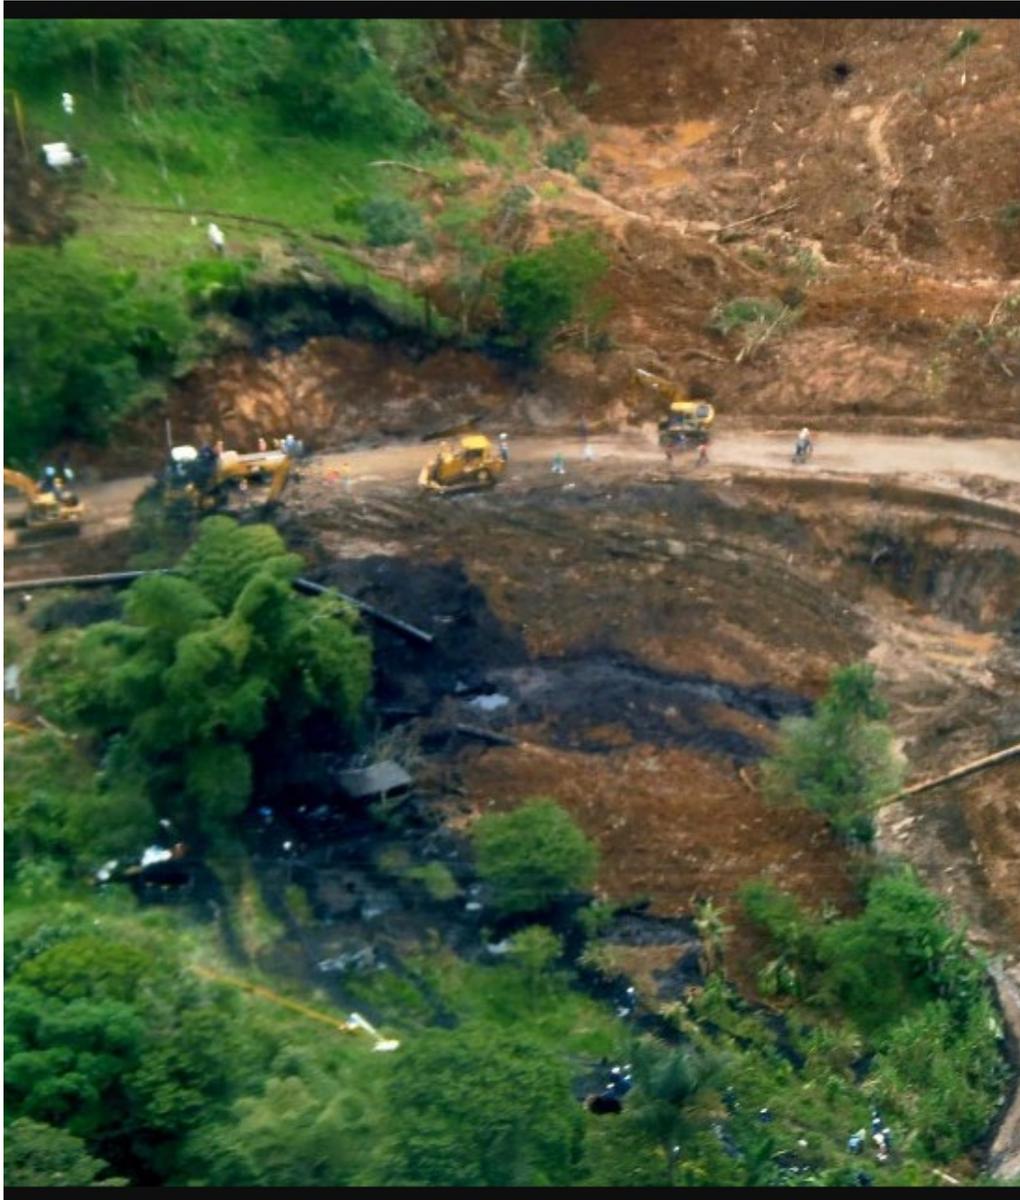
Pipeline Integrity Management – Pipeline failure photo (Trans-Ecuador crude oil pipeline rupture 31st May 2013)

One of the largest impacts of landslides occurs when the slide severs an oil or gas pipeline, allowing a release into the environment. Given that pipelines are increasingly being built in landslide-prone terrain this is a real problem. A clear illustration of this occurred in Ecuador on 31st May, when the Trans-Ecuador pipeline ruptured in a landslide. This image, released by Petroecuador, shows the landslide site:

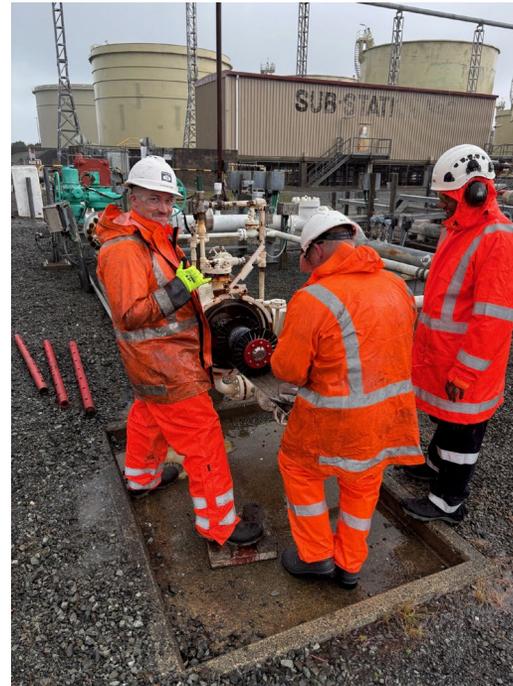
Launched the tool at Marsden Point on 18th Nov

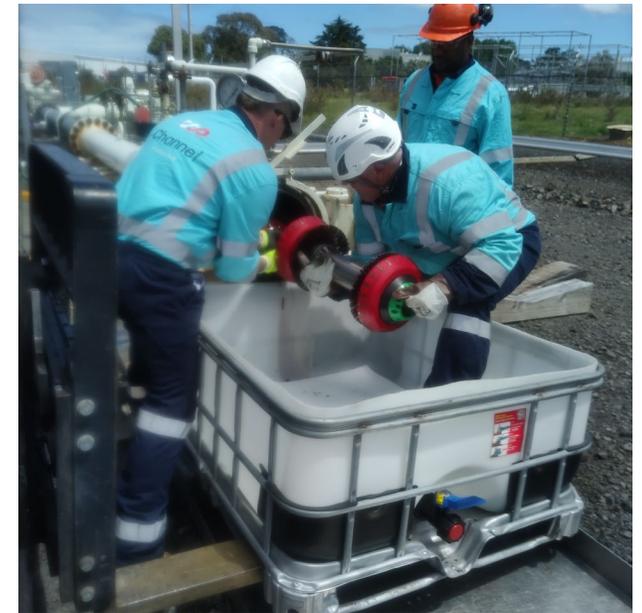
Received the tool at Wiri on 20th Nov

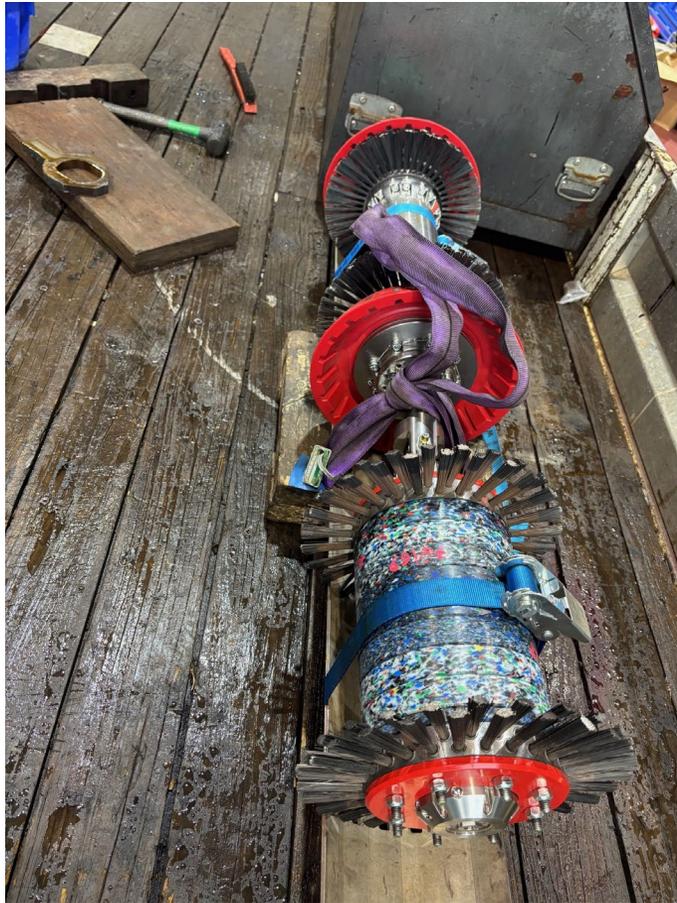
Tool before launching

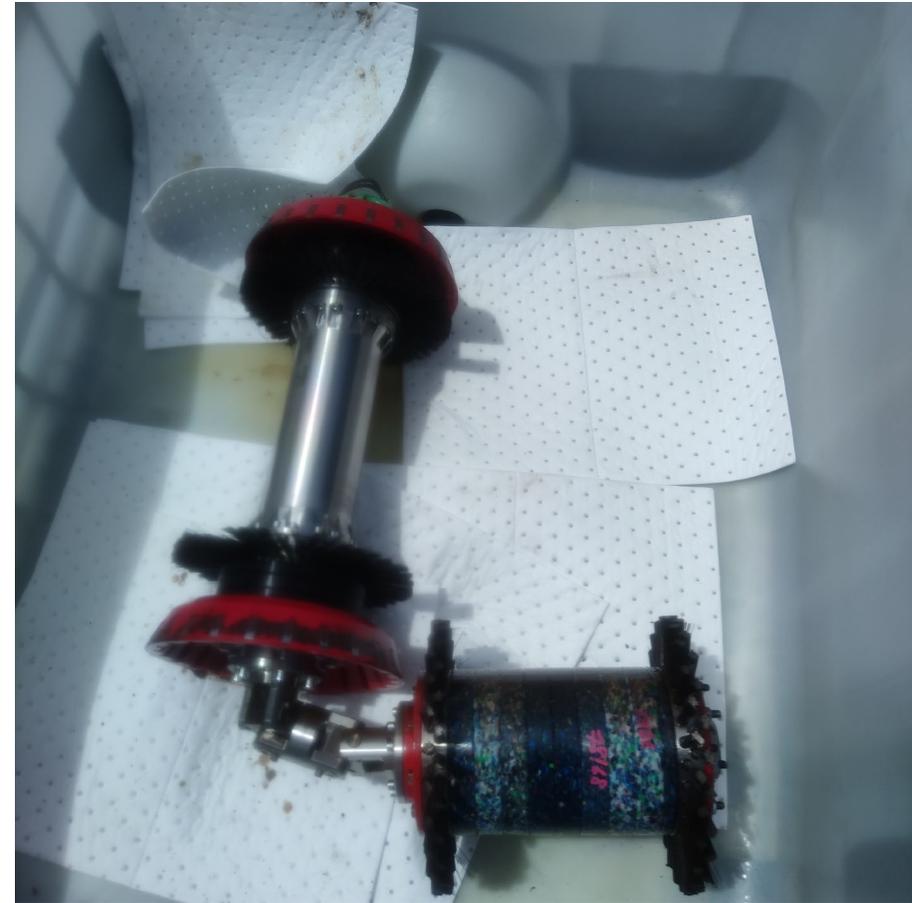
Tool after receiving

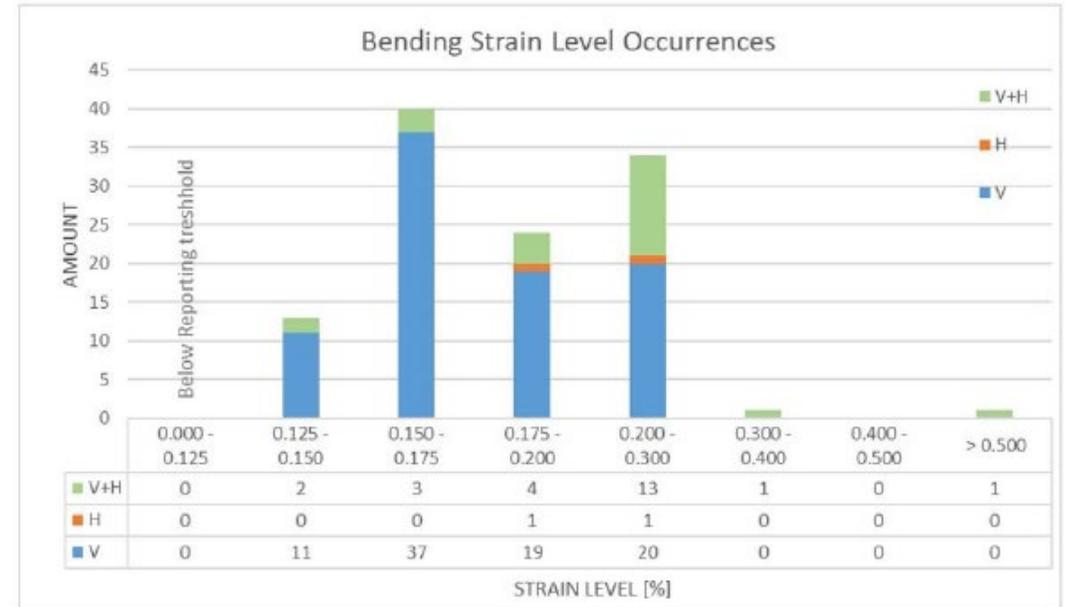
- The Nov 2025 pipeline movement data was compared against the 2022 Rosen III data sets.
- A bending strain evaluation was performed – all conspicuous bend areas with more than 0.125% bending strain were visually interpreted and classified.
 - There were 2 areas with horizontal bending strain.
 - There were 87 areas with vertical bending strain.
 - There were 24 areas with horizontal and vertical bending strain.
 - There are no areas with possible construction irregularities (COIR) found.
 - The maximum calculated total bending strain value is 0.500%.
- There are 2 areas of pipeline movement with measured movement of greater than 0.200m (maximum measured movement 0.426m).
- Industry threshold for pipeline strain is 0.6% for further assessment.

- Reported bend strain areas grouped based on strain level and bend direction:

- The bending strain of 0.500% and maximum measured pipeline movement of 0.426m necessitates a Level 2 Bending Strain Assessment.
- This detailed assessment provides a more rigorous evaluation of pipe stress, deformation behaviour and potential interaction with geotechnical conditions.
- Level 2 assessment is supported by further geotechnical and engineering investigation to confirm ground stability, and assess potential for continued displacement.
