AC Corrosion Mitigation

Eastern Gas Pipeline (EGP)

5 March 2026

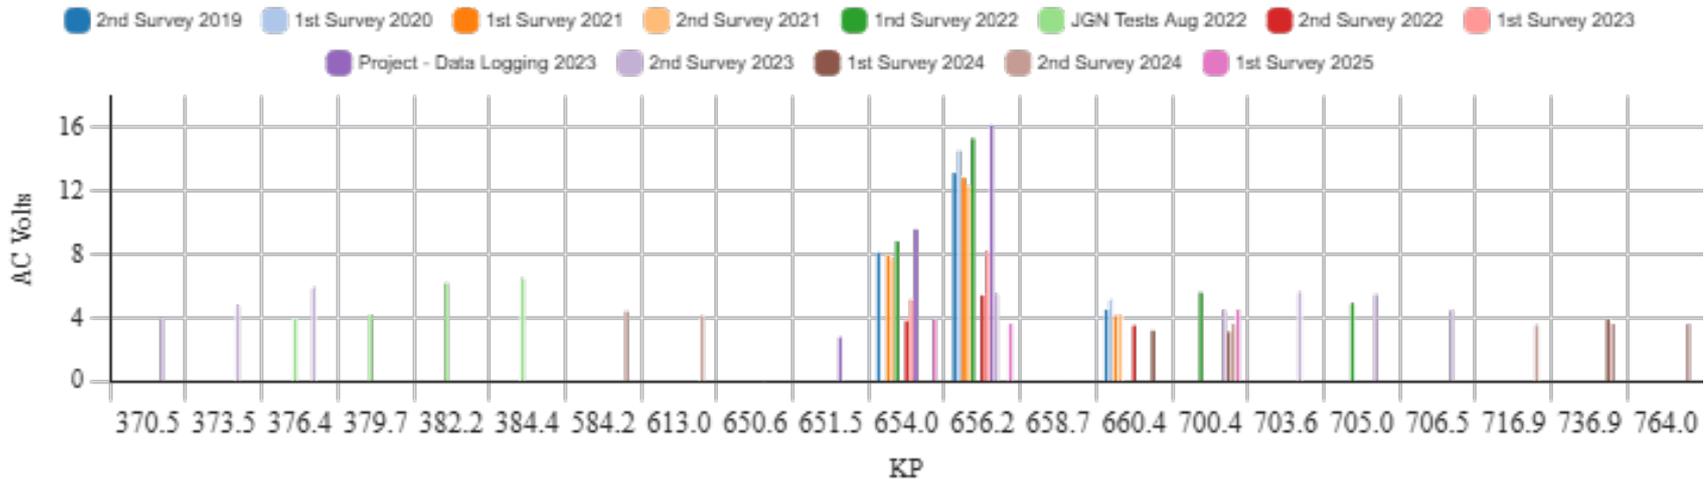
AC Volts vs KP — All Surveys (2019–2025)

KP 370 - KP 380 (ongoing monitoring)

48 hrs data logging completed (Dec 2025) and soil resistivity completed.

No immediate risk of AC corrosion at this stage (AC current density below 30 A/m²)

KP 650 – KP 660 (immediate action)

Data logging and soil resistivity completed.

Risk of AC corrosion identified at KP 656

KP 700 – KP 716 (further investigation)

48 hrs data logging completed (Dec 2025)

Soil resistivity is scheduled to be completed and AC corrosion risk to be assessed.

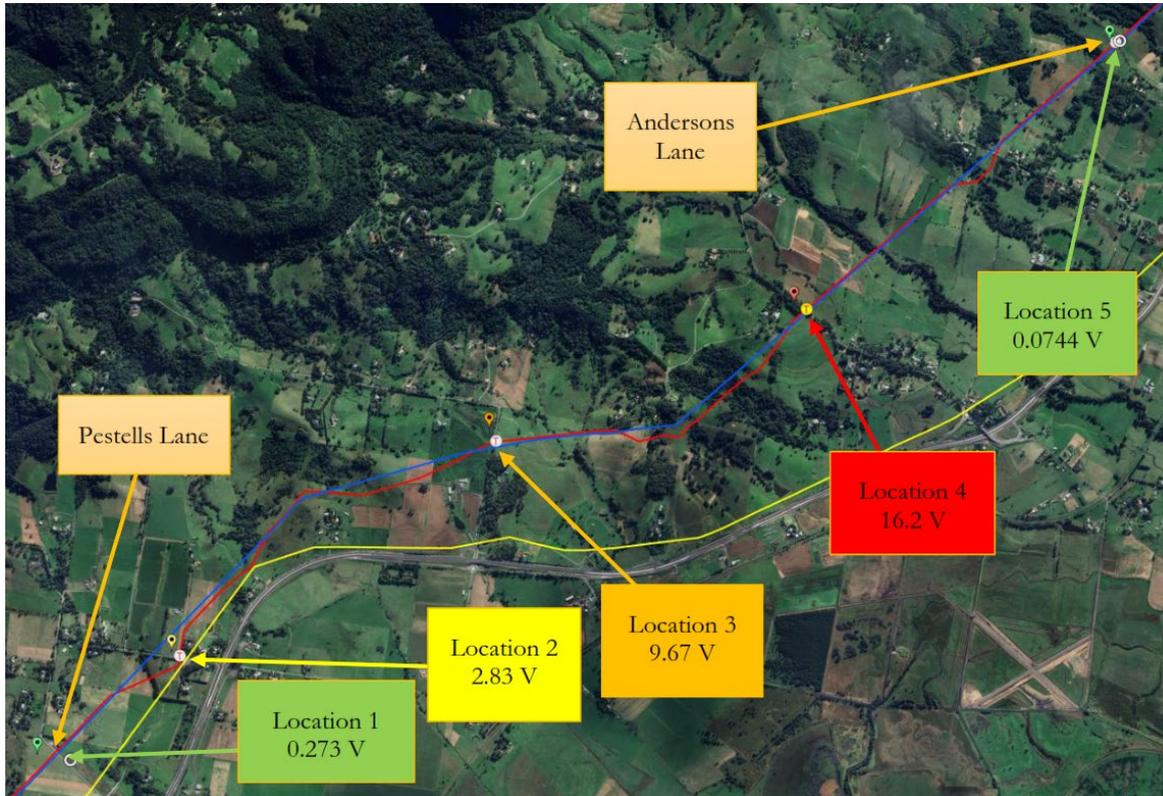
AC Potentials Data Logging (KP 650 – KP 658)

Location - KP	Top Layer Resistivity (Ωm)	Top Layer Depth (m)	Average AC (V)	AC Current Density (A/m ²) 1 cm ² coating defect	Risk of AC Corrosion
Location 1, KP650.6	9.7	11.5	0.27	6	Low
Location 2, KP651,6	25.4	3.0	2.83	25	Low
Location 3, KP654.0	64.9	2.5	9.67	34	High
Location 4, KP656.2	21.8	0.7	16.19	168	Very High
Location 5, KP658.7	117	0.6	0.07	0.1	None

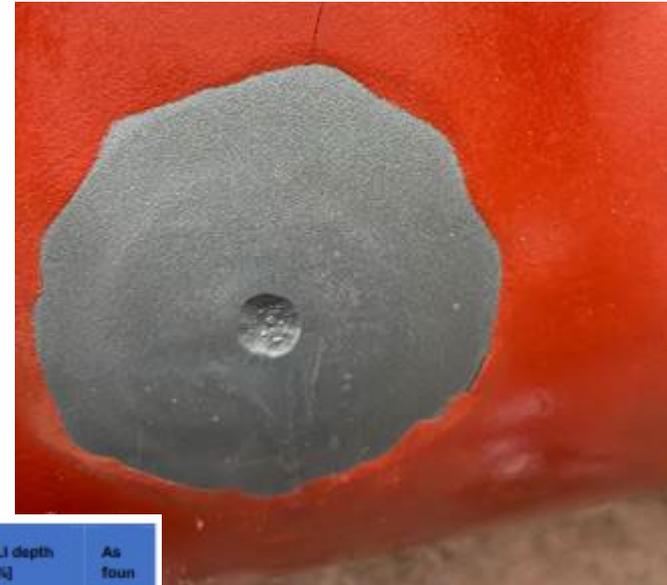
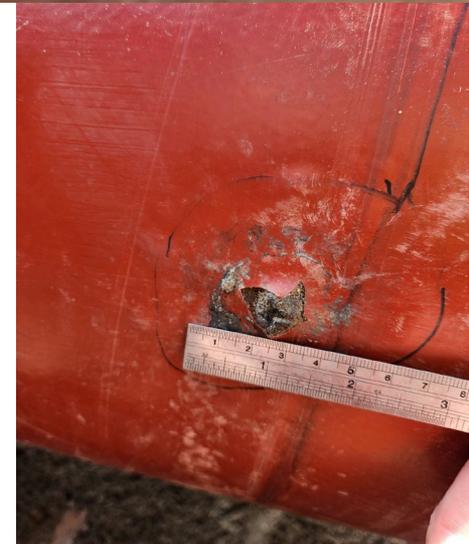
- To validate if features are due to AC corrosion as some corrosion features reported were mill anomalies two features were subject to dig up
- Controls were put in place for dig ups in high AC area – including installing PCR at nearest TPs and checking AC voltages prior to works
- Dig up confirmed AC corrosion
- Characteristic – small coating defect, small circular dimples in the pit

log dist. [m]	to uls w. [m]	wt nom. [mm]	o'clock	anomaly identification	ILI length [mm]	As found length mm	ILI width [mm]	As found width mm	ILI depth [%]	As found depth %
94937.397	-0.239	9.8	9:04	Corrosion	14	20	16	20	16	17
94937.403	-0.245	9.8	7:10	Corrosion	16	20	18	20	11	19
94964.49	-9.23 (2.54m to downstream weld)	9.8	5:26	Corrosion	16	18	25	19	11	20
94964.558	-9.298	9.8	4:53	Corrosion	16	20	17	23	16	21

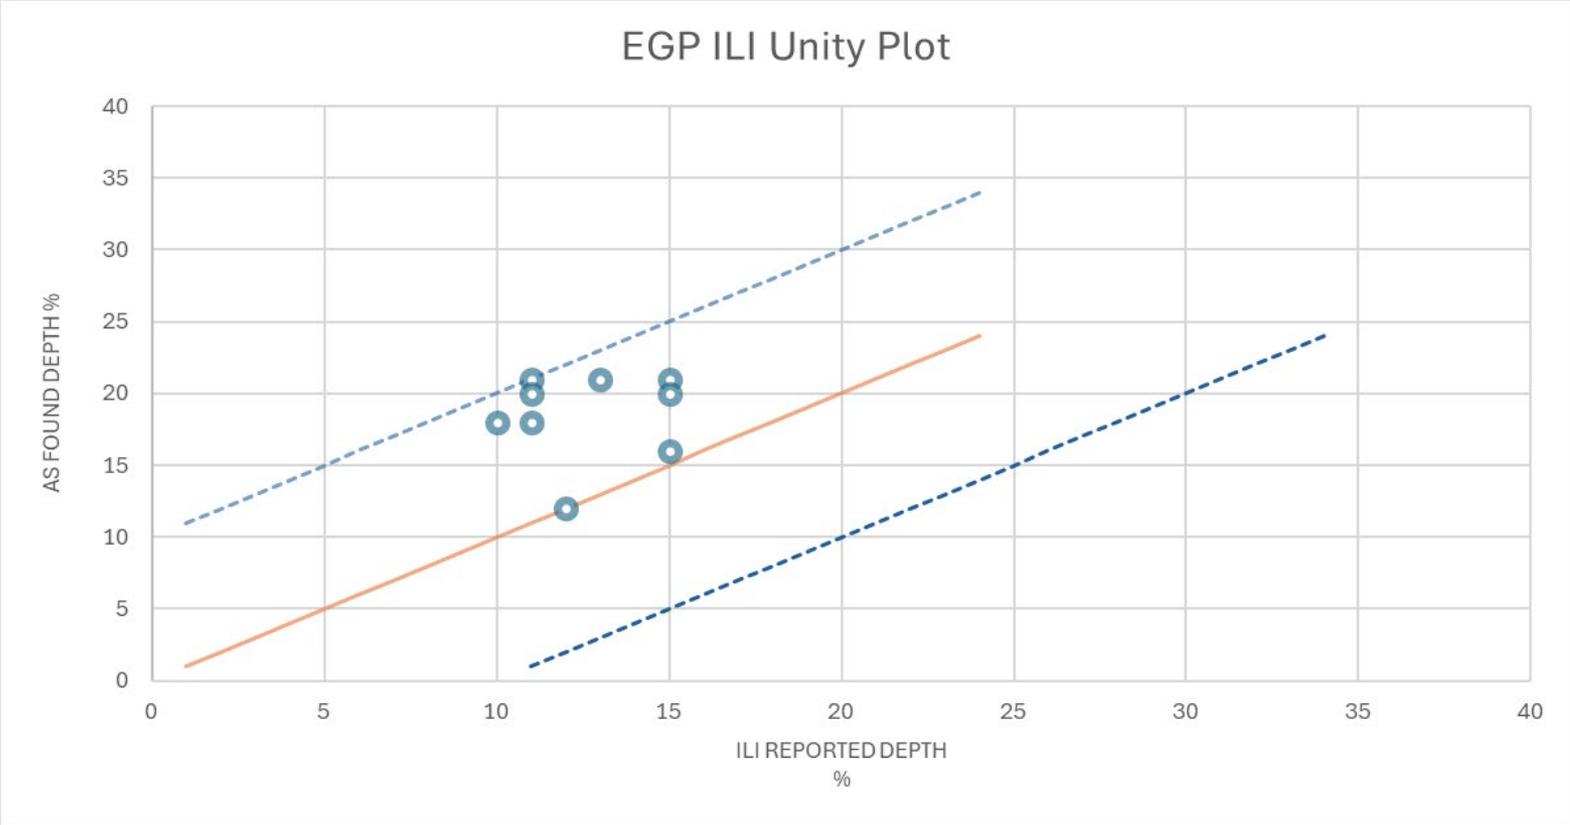
ILI vs Dig Up Unity Plot

- Further validation digs undertaken (7 sites), including features that were below reporting threshold of 10%. This was achieved by getting ILI vendor to check signal data
- Overall ILI data was within specification for sizing
- All reported corrosion identified as AC Corrosion
- Some unreported pitting, due to being below tool detection capability

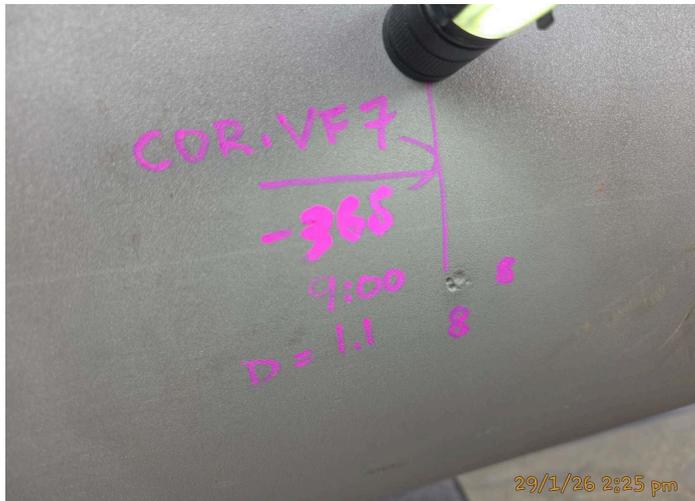
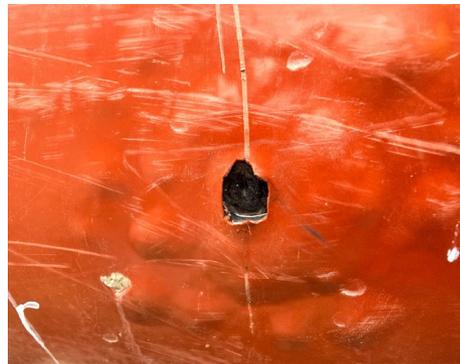
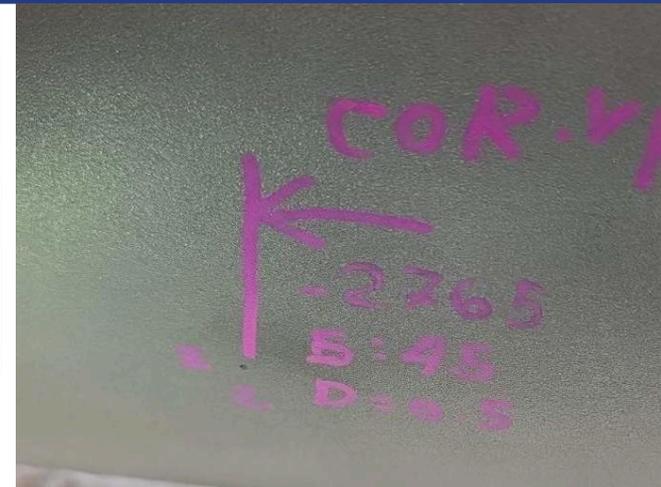
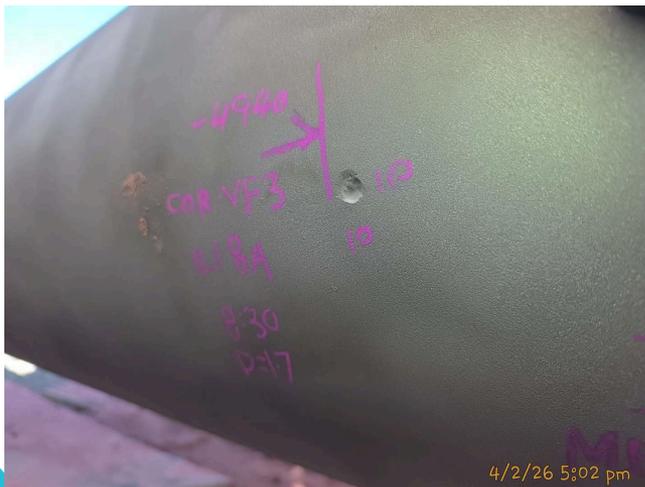
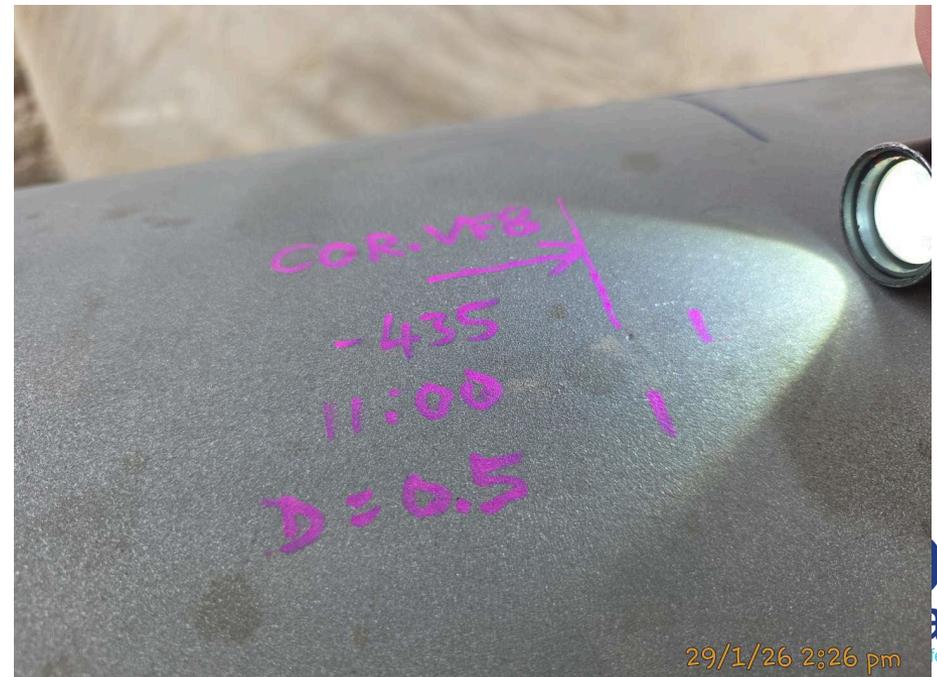
Dig up photos

Section / KP approx.	O'clock	As found O'clock	ILI Length [mm]	As found length (mm)	ILI width [mm]	As found width (mm)	ILI depth [%]	As found depth %
KP653.663	4:48	4:57	10	8	15	10	10	18
KP656.115	12:04	12:09	13	12	19	13	11	18
	12:00	11:50		6		5	<10%	10
KP656.181	3:05	3:23	13	12	17	16	12	12
	4:42	4:52	17	20	18	17	15	21
KP656.282	6:18	6:50	15	16	20	16	13	21
	4:40	5:11		10		10	<10%	14
KP656.315	4:00	4:00					<10%	9
	4:09	4:00	13	13	18	23	15	16
KP656.325	5:22	5:17	13	16	19	18	15	20
	4:16	4:11	11	9	15	10	11	21
KP659.596	8:20	8:20		5		5		16
	5:00	5:11	16	17	23	13	11	20
	6:30	7:54		4.86		5.9	<10%	14

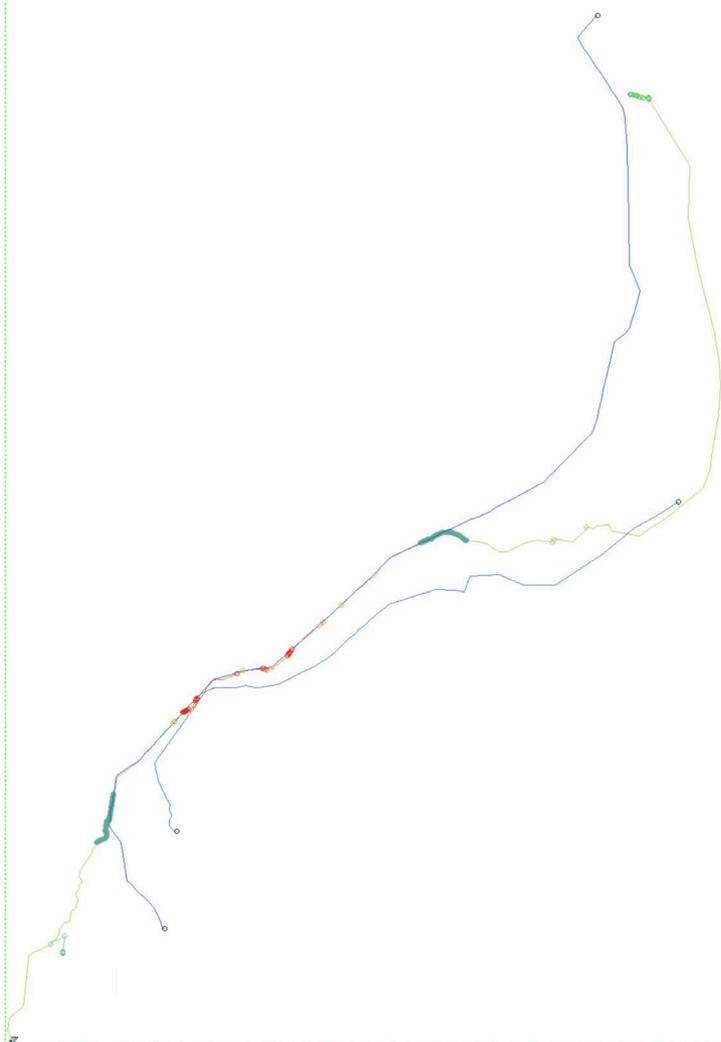
AC System Modelling Vs. Data Loggers

Location	Logged average AC (V)	Modelled AC (V)
1 – KP 650.6	0.273	0.670
2 – KP 651.6	2.83	1.40
3 – KP 654.0	9.67	8.70
4 – KP 656.2	16.2	16.2
5 – KP 658.7	0.0744	0.0940

- Above : AC Voltage Measurements VS Modelled Voltages (Existing System)
- Left : CDEGS Model of the Pipeline and 132 kV Circuits

Twin-circuit 132 kV powerline is simplified as a single conductor, representative of the total imbalance of the superimposed magnetic fields of each conductor in both circuits. An overall current magnitude of 230.6 A in this single-conductor system, representative of the same cyclical nature of the logged voltages, is found to be the best match in this model

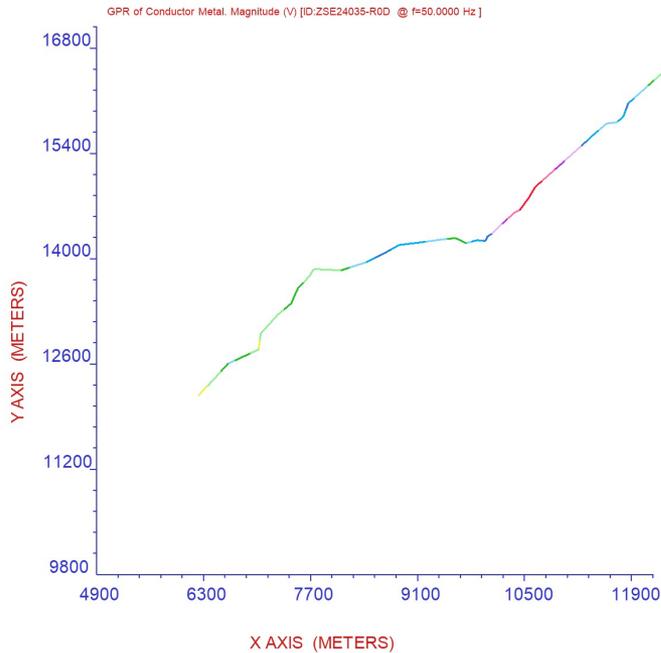
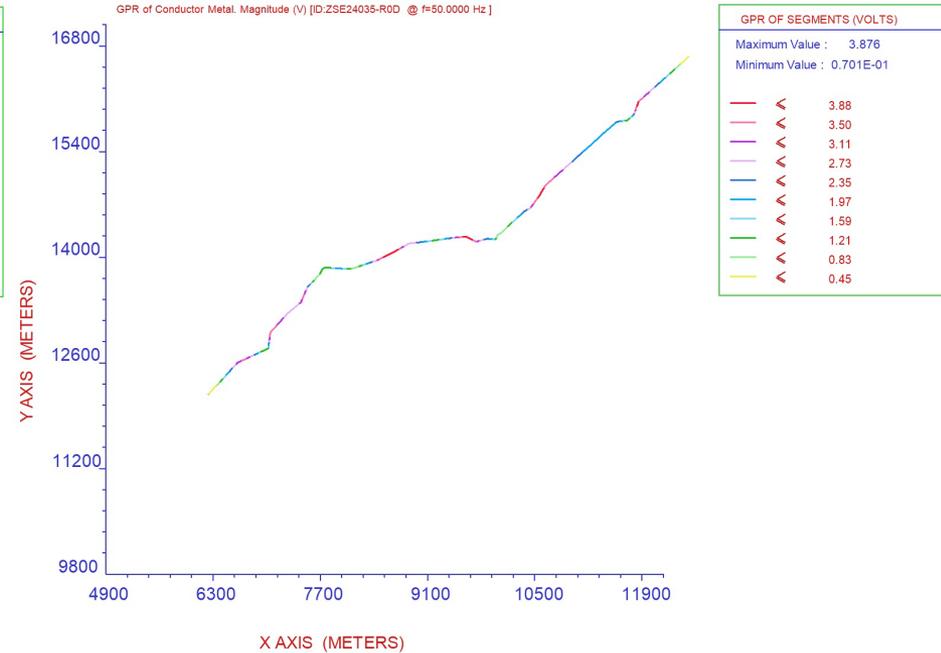
Initial AC Mitigation System Modelling

- Modelled Steady State Pipeline AC Voltage (Existing) , top left
- Modelled Steady State Pipeline AC Voltage (Mitigated System) , top right,
Mitigated model is based on installation of 25 off 1Ω earth points to reduce the entire 8 km section consistently below 4V AC
