# MAPS Flood Recovery and Reinstatement Project

A case study of effective emergency management

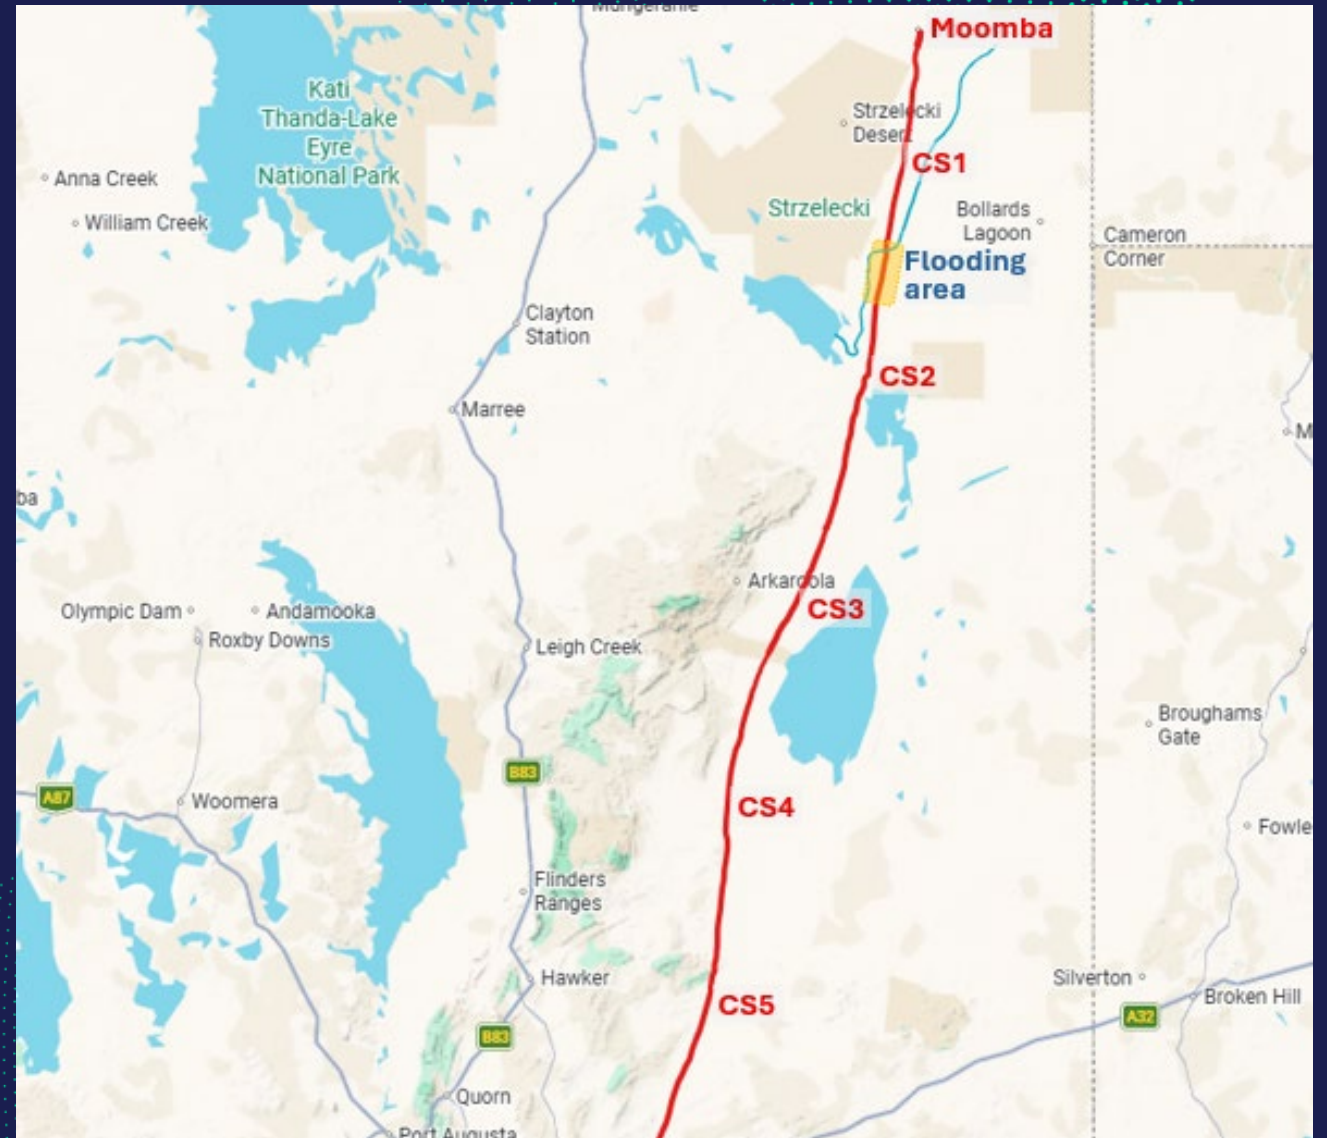
The flooding caused:

- Exposure of ~530 metres pipeline
- 6 separate locations exposed
- Potential pipeline floatation
- Extensive road damage and restricted site access
- Damage to cathodic protection
- Damage to SWER line infrastructure

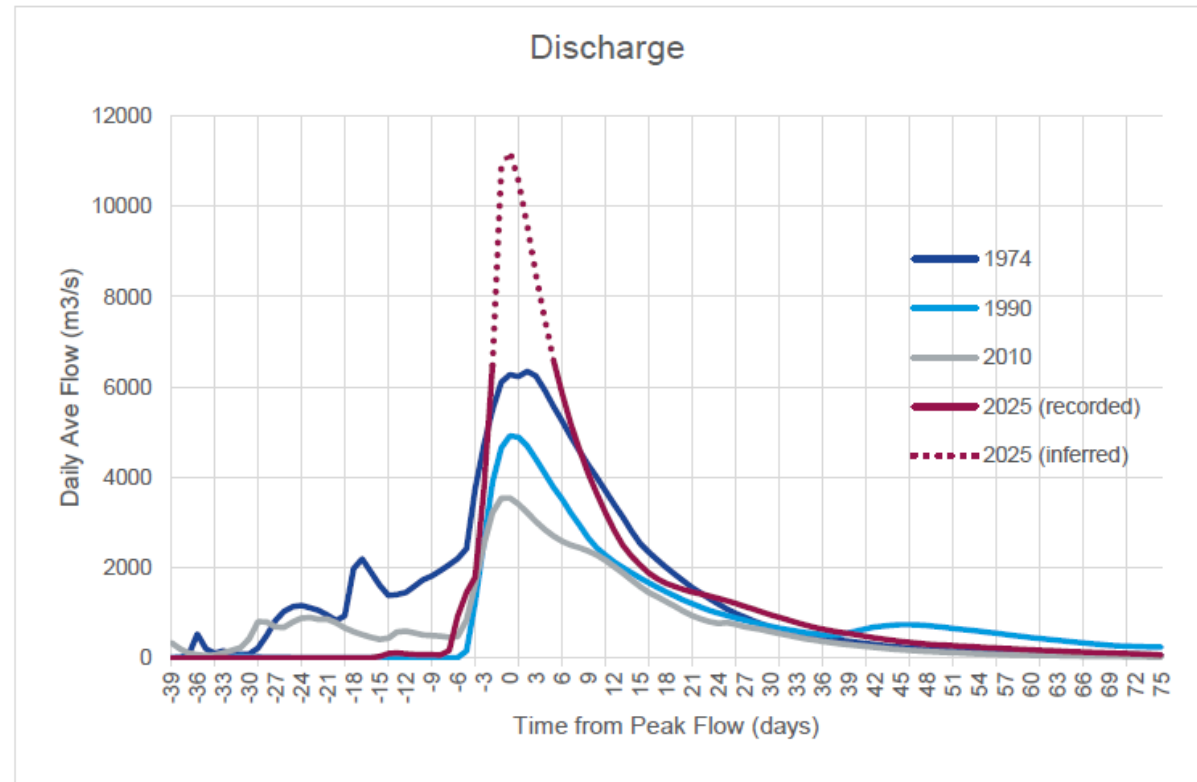
Figure 2: Cooper Creek Historical Event Hydrographs

Note: data gap in 2025 between 8-15 April where streamflow gauge did not report. Flow estimated by Ricardo using flow to level relationship, refer Appendix A. Shown as '2025 (inferred)' on graph.

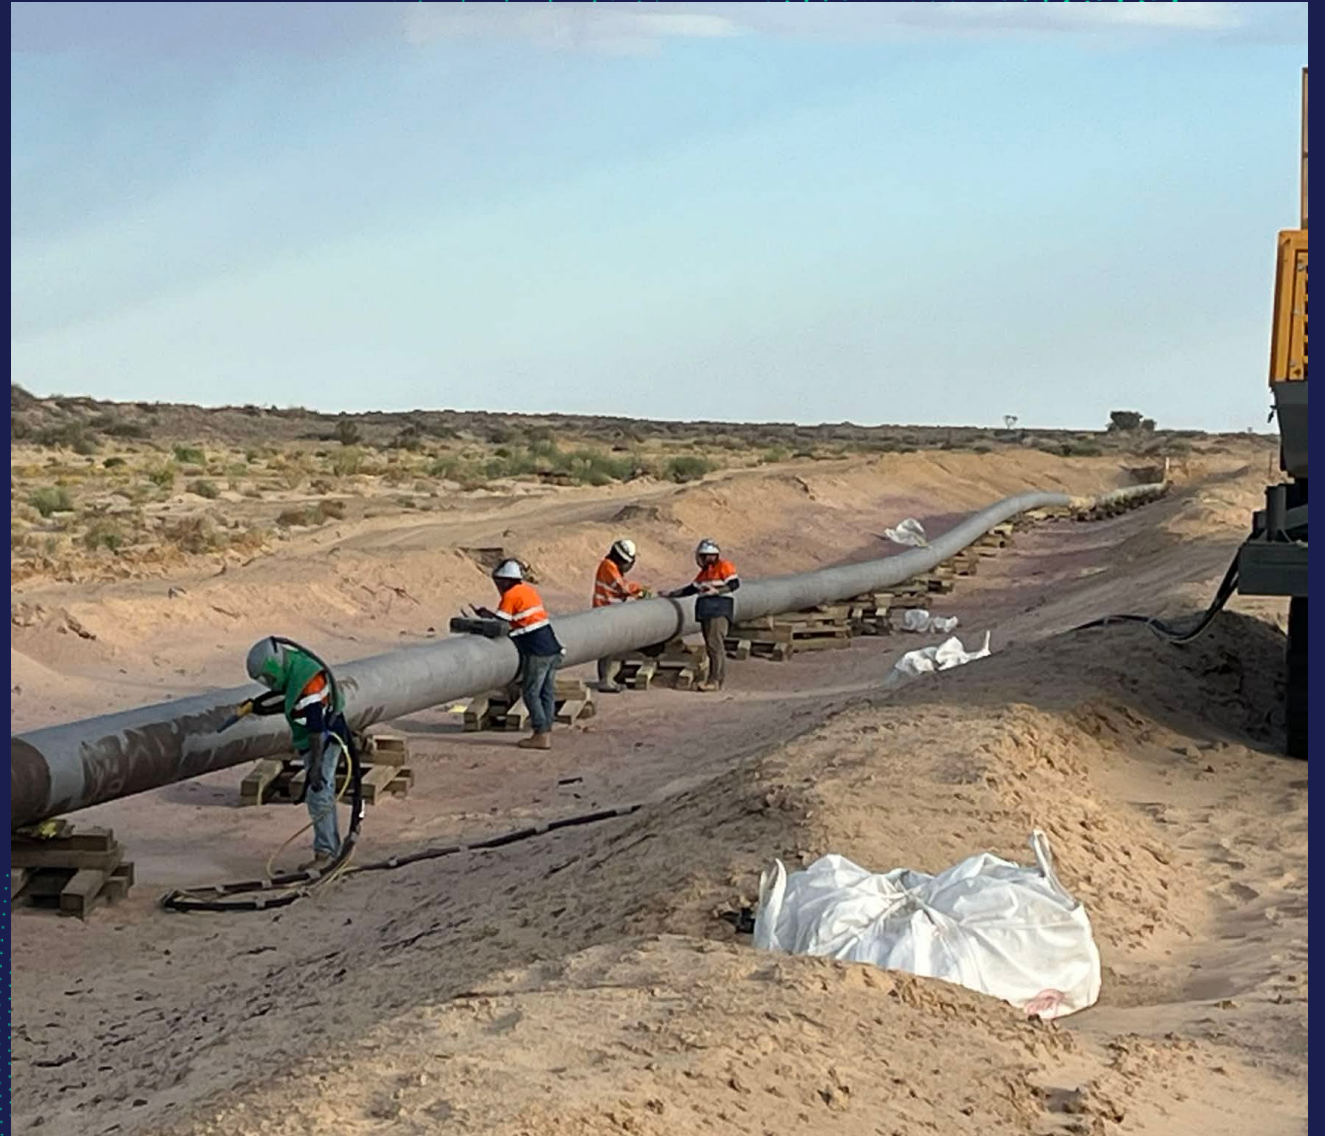
- Visual inspection, coating and corrosion checks
- Ovality
- Weld profile and seam location confirmation
- Wall thickness verification

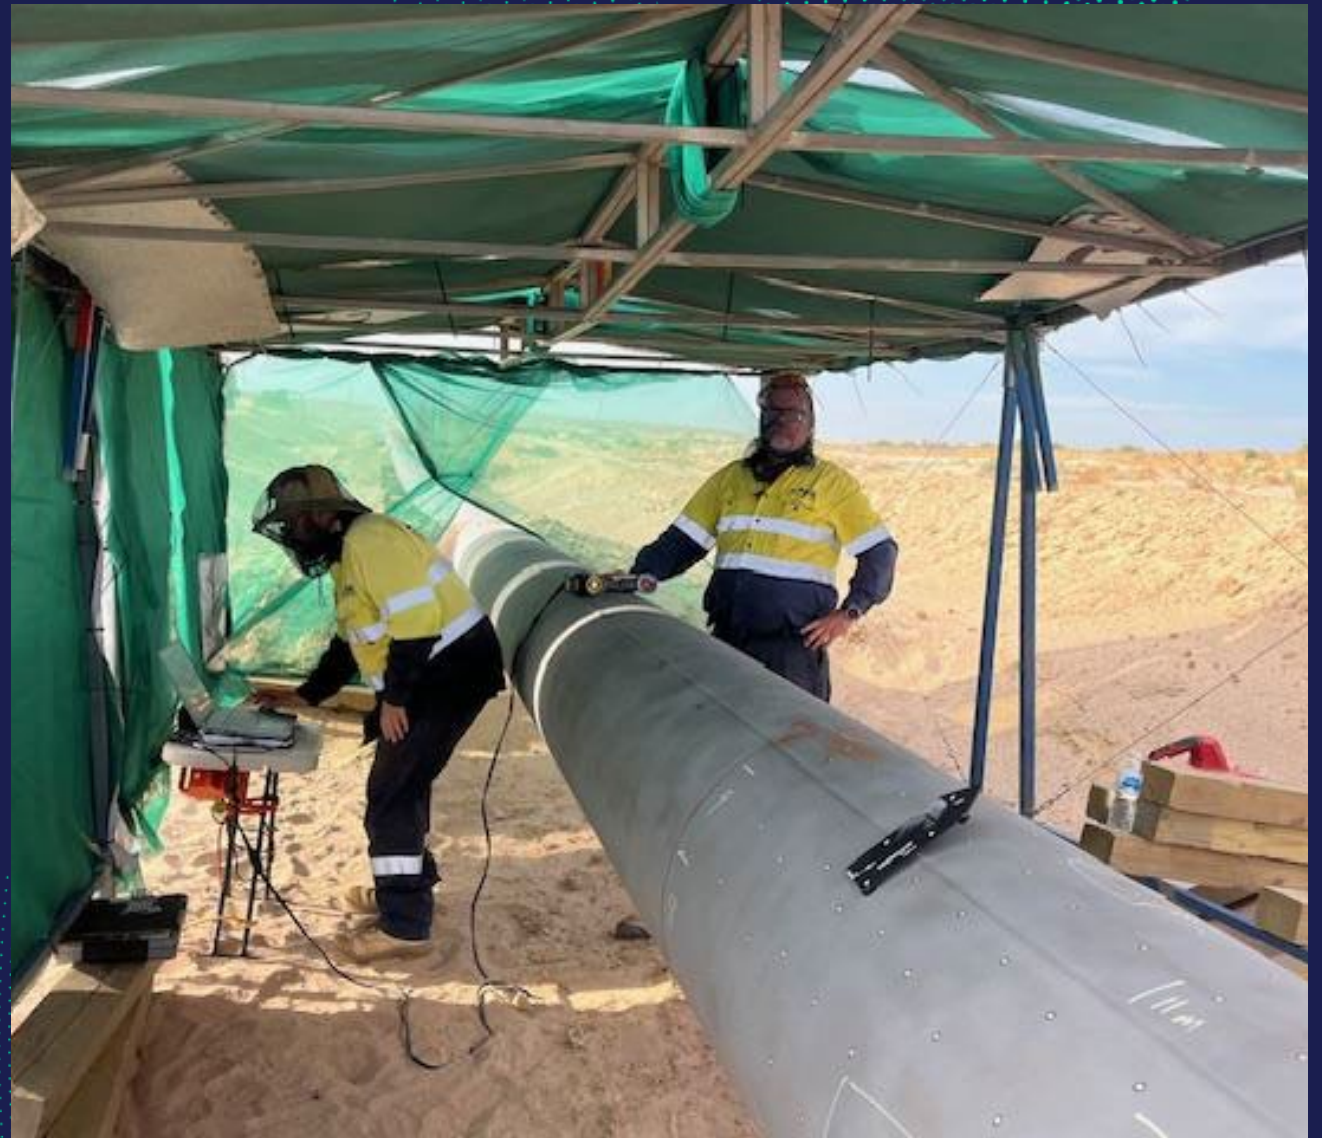
- 100% NDT for exposed lengths
- Circumferential welds (ext.): MPI
- Circumferential welds (int.): PAUT
- Corrosion Areas (ext.): MPI
- Longitudinal seam welds (ext.): Eddy Current Array (SPYNE)
- Full pipe body: ECA (SPYNE) and Creaform 3D laser scanning
- Wall thickness verification: UT thickness measurements
