Western Outer Ring Main (WORM) Project A Contractor 's Perspective

Presenter: LEIGH SMITH

1. Project Introduction– Western Outer Ring Main (WORM)

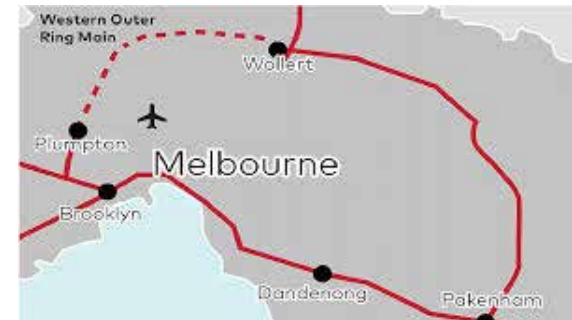
- Spiecapag was engaged by APA Group to construct the pipeline.
- Primary benefit of the WORM is to enable east-west flows of gas between Longford and Iona, and also gas to and from the Victorian Northern Interconnect (VNI).
- Opportunity for natural gas supply to new growth areas in the Northwest of Melbourne (Sunbury, Merrifield & Kalkallo).

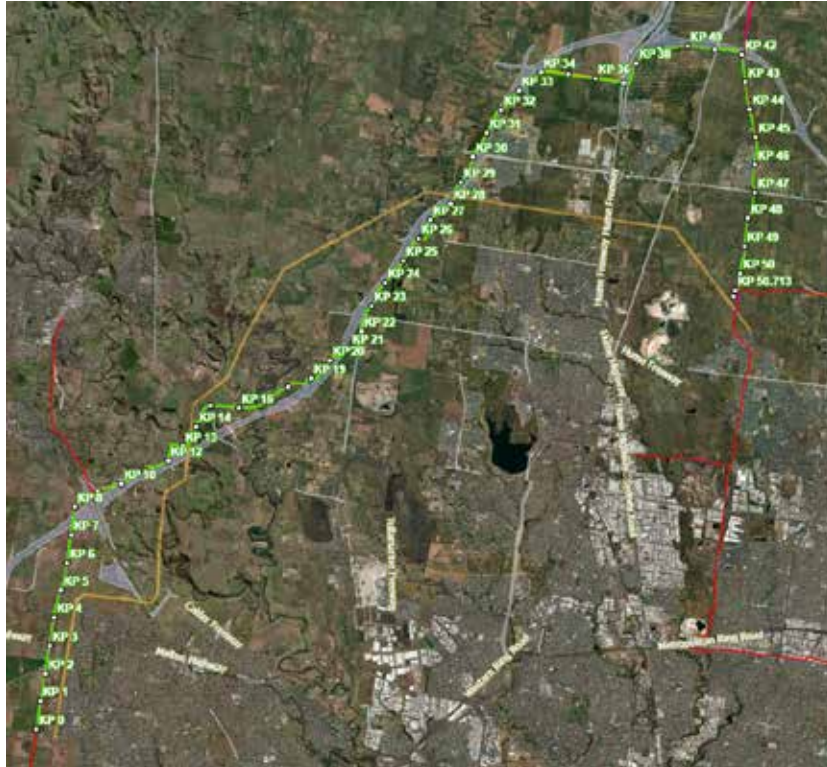
b) Contractor's Scope of Work

- The installation of 51km X52 20" (DN500) Gas Transmission Pipeline between Plumpton & Wollert
- Combination of Standard Wall (10.31mm) and Heavy Wall (12.70mm)
- Construction of 3 off Main Line Valve Stations
- Construction of 450m pipeline between WORM Scraper Station & WORM Control Valve

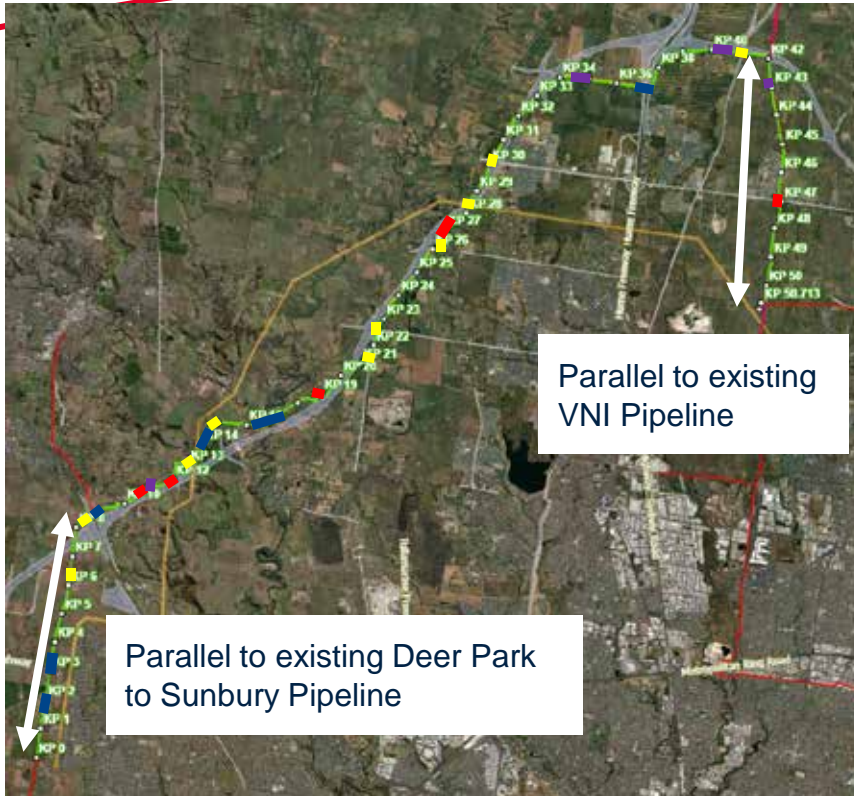
a) General Overview

- Alignment follows the Future OMR (Outer Metropolitan Ring Road)
 - 8x Additional Depth of cover crossings (3-4m cover) Due to pipeline being within PAO – Public Acquisition Overlay
- 6x HDD Crossings

- 10x Micro tunnel Crossings
 - 2x Rail Crossings

- 5x open cut road Crossings

- 4x Open cut Creek Crossings

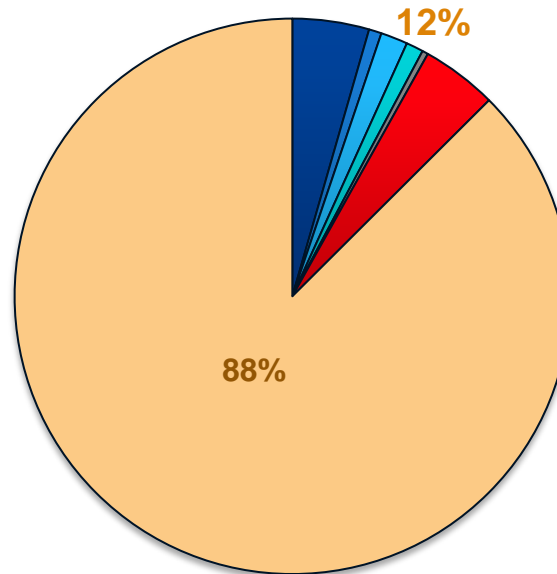
WORM Pipeline Construction Methodologies

■ HDD ■ Thrust Bores ■ Road X-ings (Open Cut) ■ Creek X-ings (Open Cut) ■ Insertions ■ PAO Sections ■ Open Cut

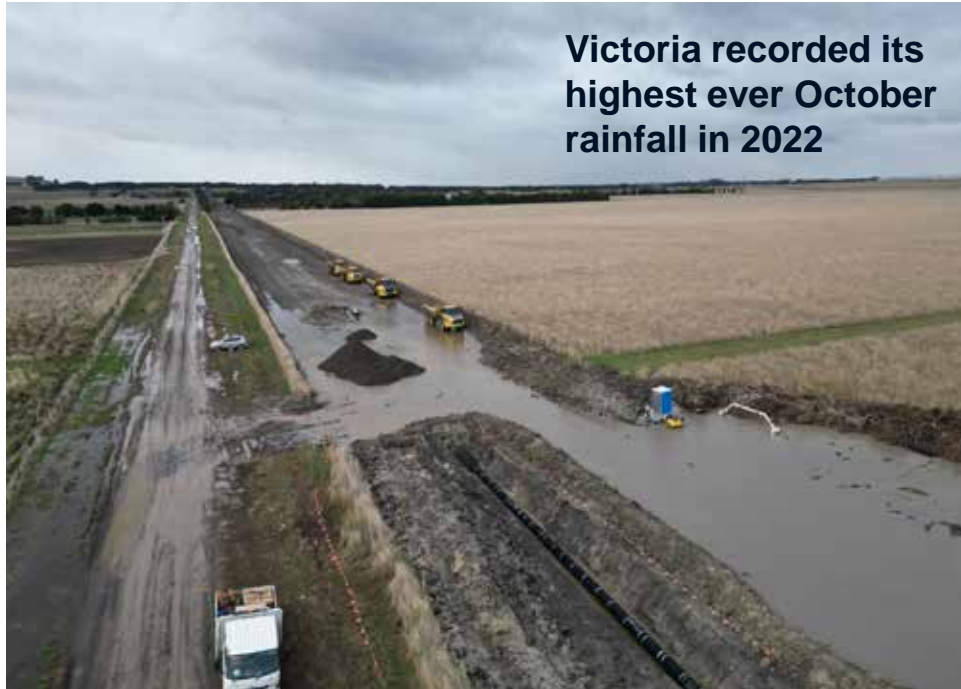
a) General Overview – Inclement Weather, Flooding & Ground Conditions

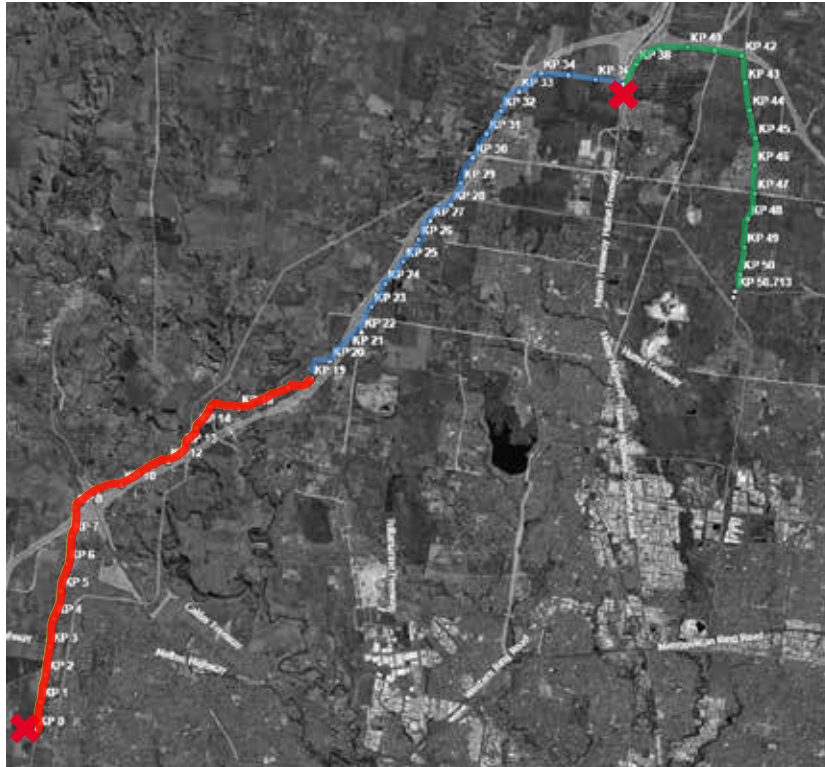
d) Hydrotest Leak Investigation

- Test Section #1 – 18km

- Test Section #2 – 18km

- Test Section #3 – 13km

- Existing Water Hydrants

- Test Section #1 Failure

- Total Test Section Volume: 3,484 m³

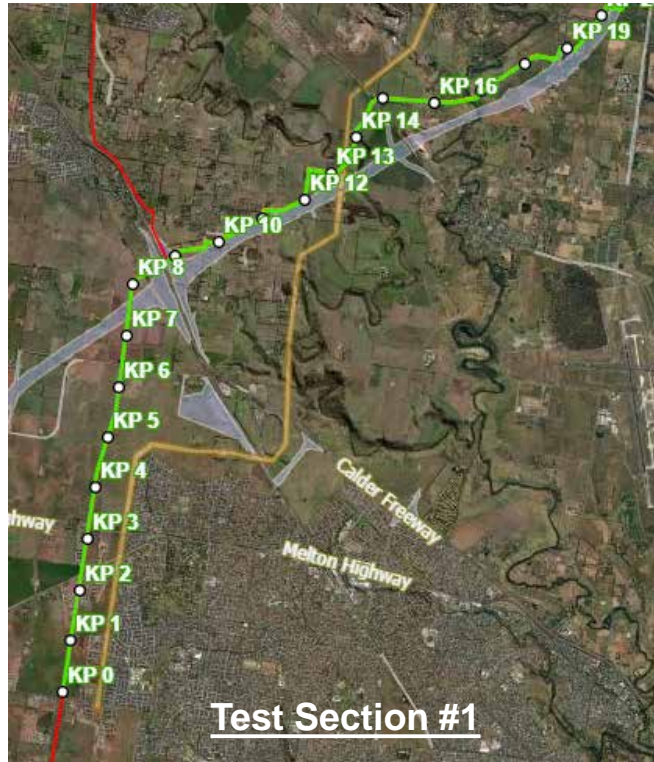
Leak Detection Methodologies

Phase 1:

- RoW Patrolling / Visual Inspection
- Acoustic Monitoring
- Direct Current Voltage Gradient (DCVG)

Phase 2:

- Cut Test Section up & Re-test
- Freeze Plugging

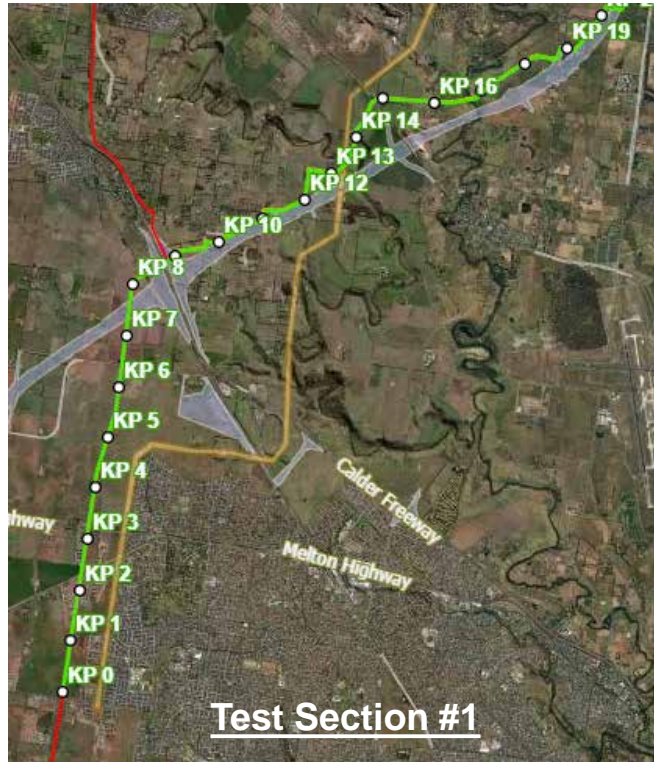
Day 1

Uncontrolled pressure loss

Phase 1

Day 5

Test Excavations to
nominate test section
breaks

Day 9

Commenced cutting pipe to
break up test sections

Phase 2

Day 13

Leak location identified

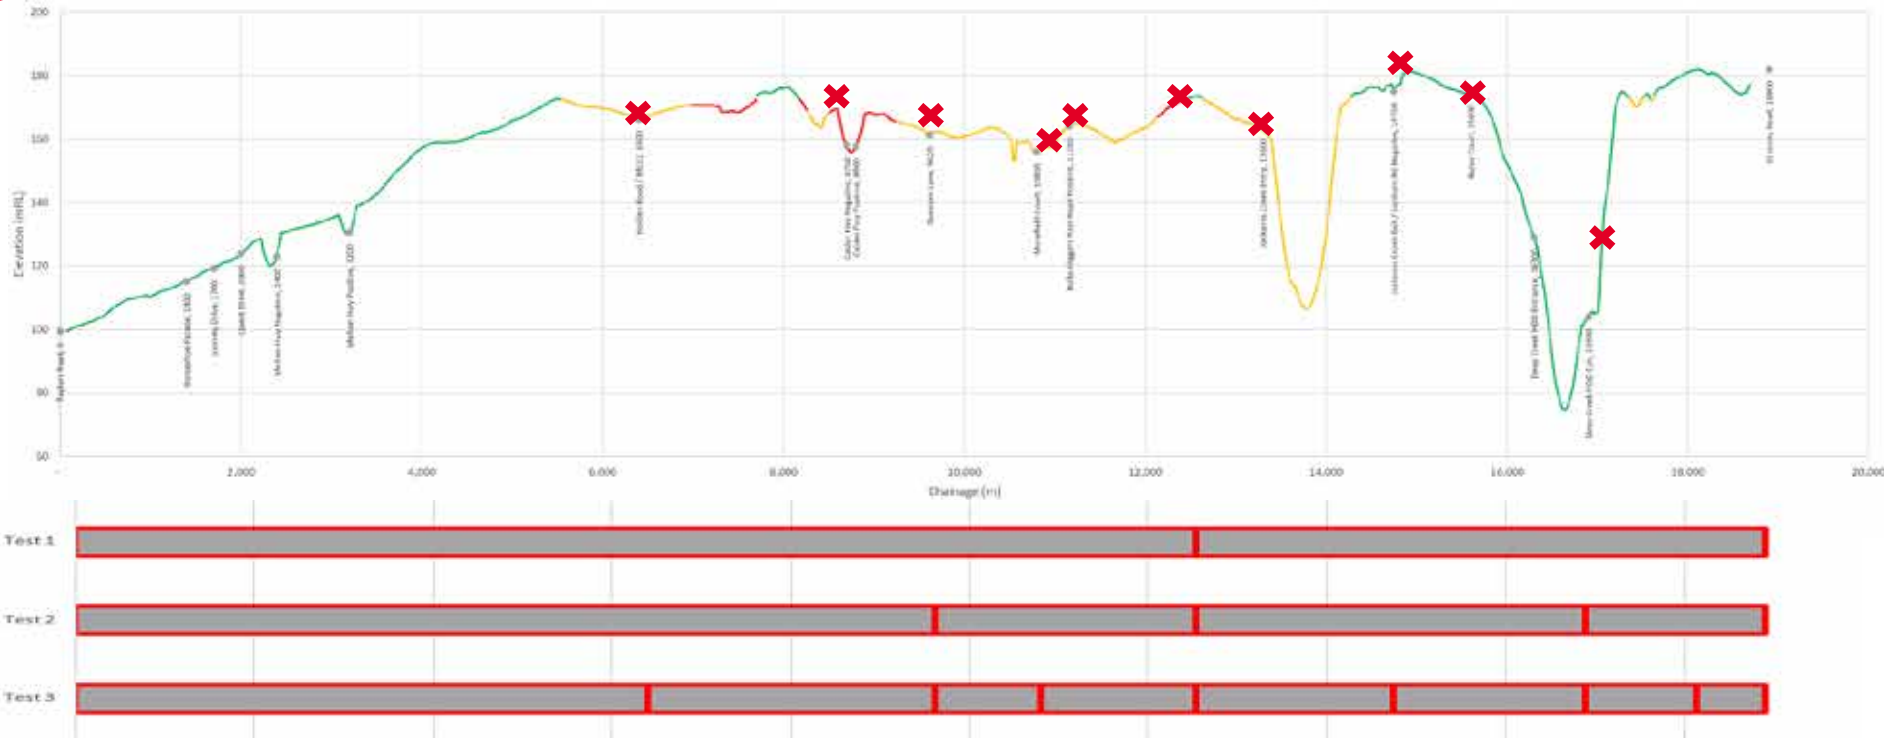
Test Excavations ✖

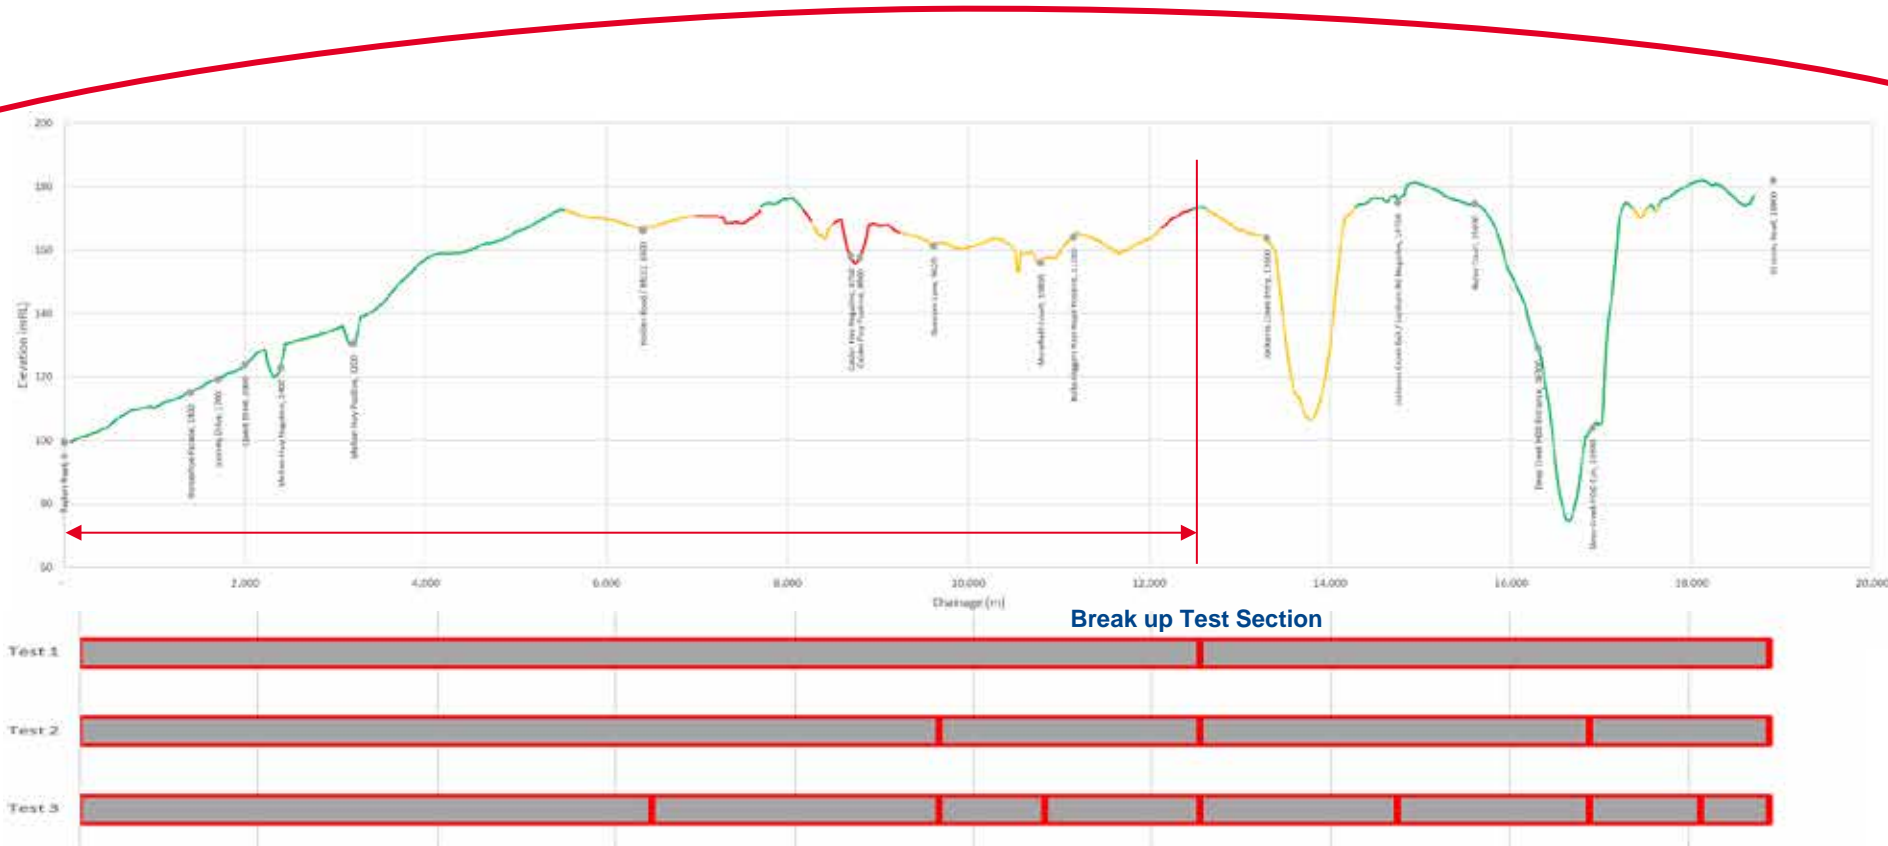
Leak Identified

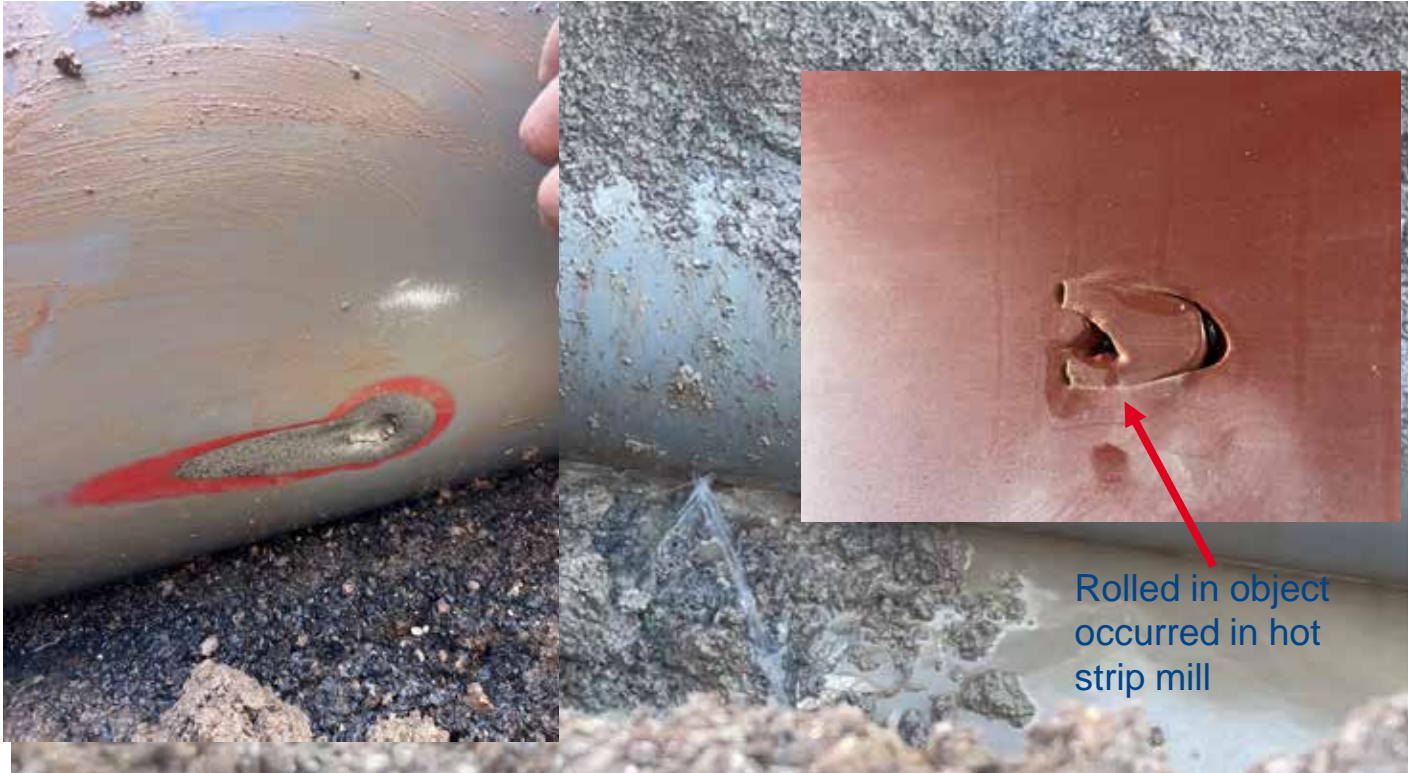
d) Hydrotest Leak Investigation

- The importance of land access cannot be underestimated
- Attracting key pipeliners on a 5.5 day/week working roster has its challenges
- Hydrotest failure - despite having stringent QA processes in place, It's not always possible to prevent the unexpected
- It's important to work collaboratively with the client from project inception to fully understand the risks and to avoid additional costs
