AC Corrosion Mitigation

Eastern Gas Pipeline (EGP)

5 March 2026

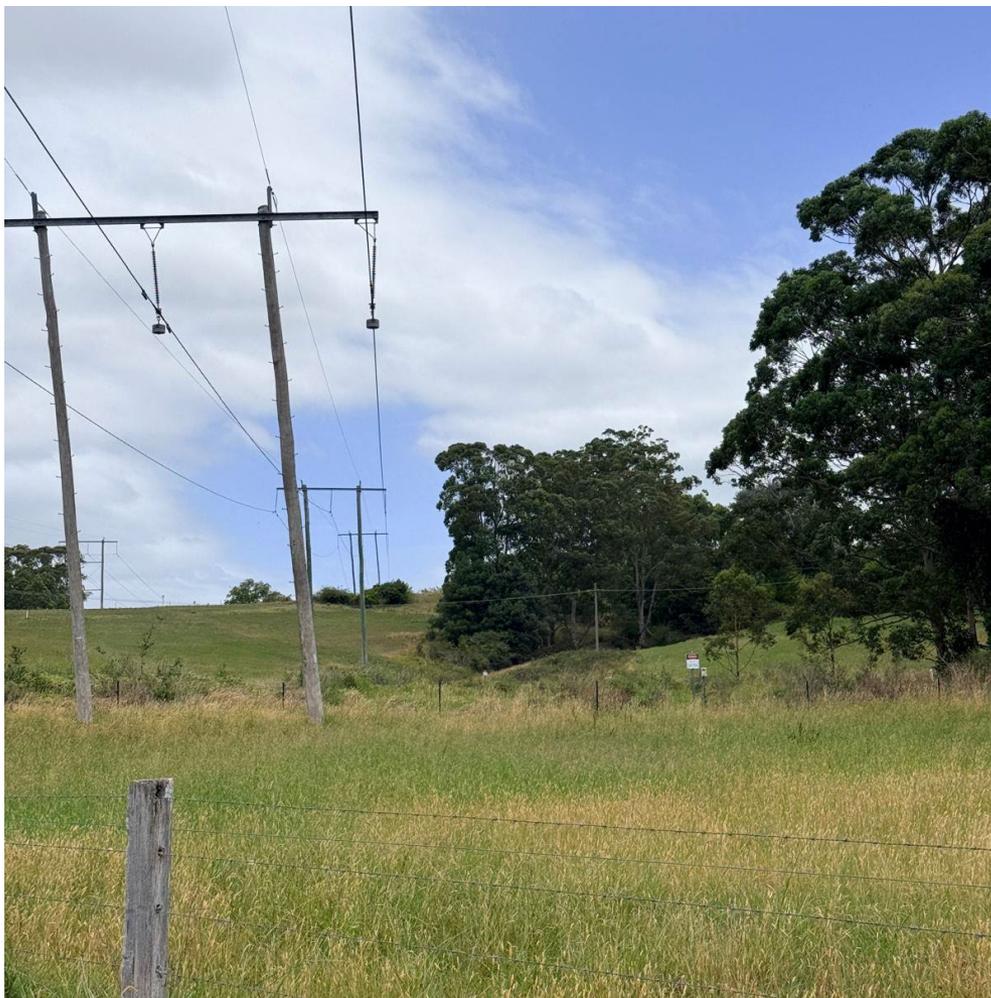
Pipeline – Powerline AC Exposure Summary

Exposure Range	Distance (Km)	Powerline Voltage
KP 25–48	23 km	66 kV
KP 117–126	9 km	66 & 22 kV
KP 160–221	61 km	66 & 22 kV
KP 315–346	31 km	66 & 22 kV
KP 361–391	30 km	132 & 22 kV
KP 403–475	72 km	132 & 11 kV
KP 564–619	55 km	330 & 22 kV
KP 643–663	20 km	132 kV
KP 673–686	13 km	33 kV
KP 716–777	61 km	330, 132, 66 & 33 kV
Port Kembla Lateral	7 km	132 & 33 kV
Smithfield Lateral	3 km	132 & 33 kV

- Length of parallel with HV: 385 km
- AC mitigation was originally designed for safety (< 15V) only not AC corrosion mitigation

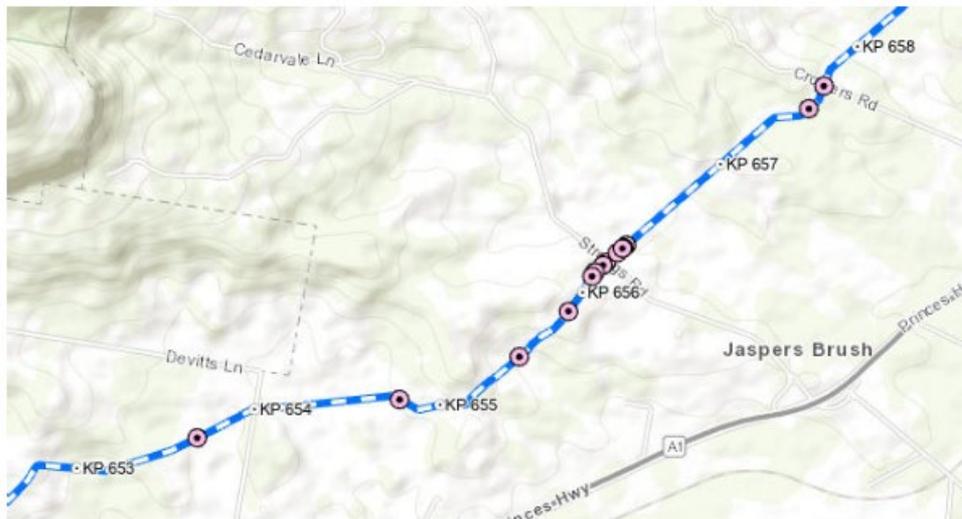
Comparison to 2012 ILI

- ILI vendor confirmed all reported corrosion features visible in signal and under reporting threshold
- Linear corrosion rate calculated using tool tolerance and conservatively assuming features were 1% in previous ILI, corrosion rate is $\sim 0.25\text{mm/year}$ or 2.5% of WT
